# Leakages and Scaling in Stainless Steel Heat Exchangers: Rules of Selection of Chemical Bath for Scale Removal Part I

Jan Marjanowski

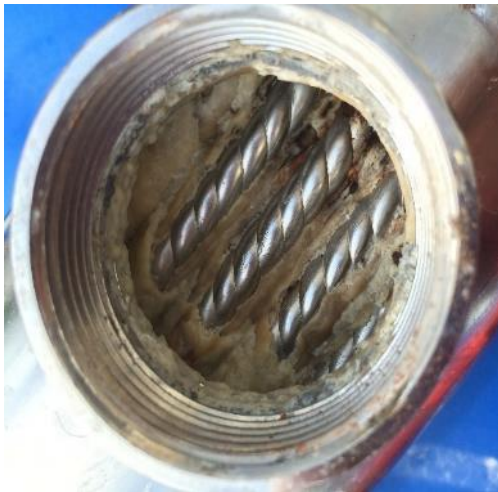
Fig.1. Flow heat exchanger inlet, covered mostly with calcium carbonate scale.

#### A. Scales containing mainly calcium carbonate $\text{CaCO}_3$ (Fig. 1).

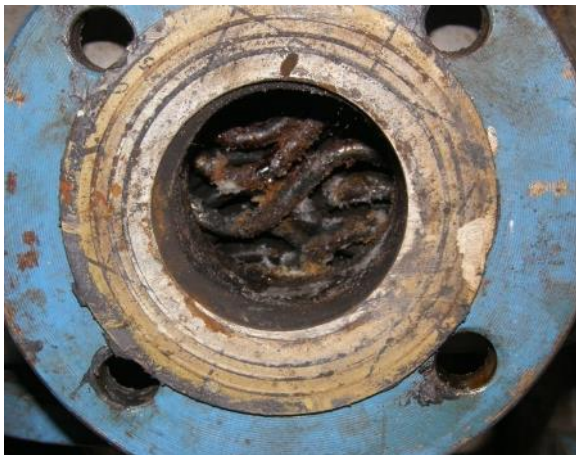
Fig.2. Flow heat exchanger inlet, covered mostly with the scale containing mostly iron compounds.

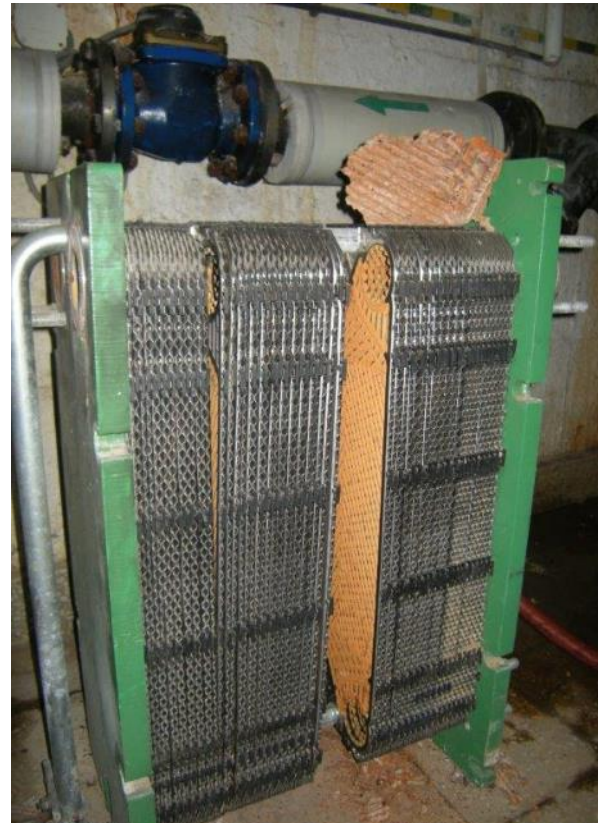
Fig. 3. Demountable flat heat exchanger covered mostly with calcium carbonate scale

Fig. 3-4 presents plate HE covered with scale. Fig. 3 shows demountable HE, covered mostly with calcium carbonate scale, whereas Fig. 4 presents fragment of brazed HE after unaffected chemical flushing that did not remove the scale.

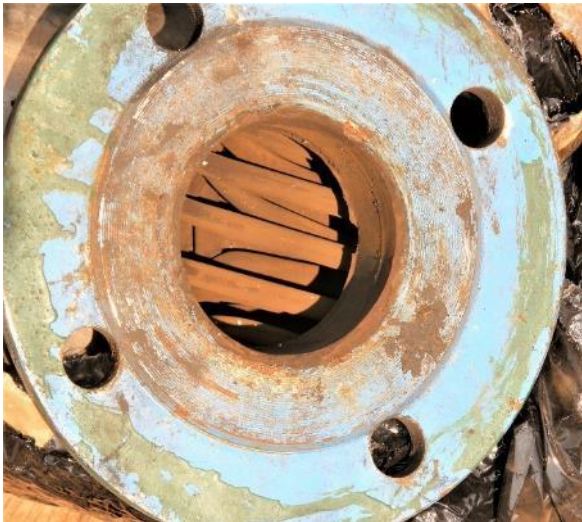
Fig. 6. JAD 6/50 flow HE inlet from DHW system, scaled with calcium and iron compounds.

Fig. 5 presents demountable plate HE with iron scale, while Fig. 6 shows flow HE inlet scaling by calcium and iron compounds.

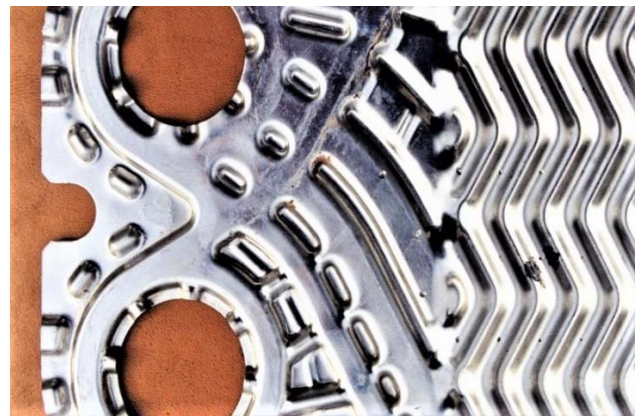
of steel. Fig. 8 presents damaged plate from demountable HE made from AISI 316 steel used in DHW system with water containing  $180 \text{ mg Cl/l}$ . The HE was not cleaned with hydrochloric acid, however, water overheating frequently occurred as a consequence of automation failures.

Fig. 8. AISI 316 steel HE plate pitting corrosion damage. Leaks were noted at the dark areas.

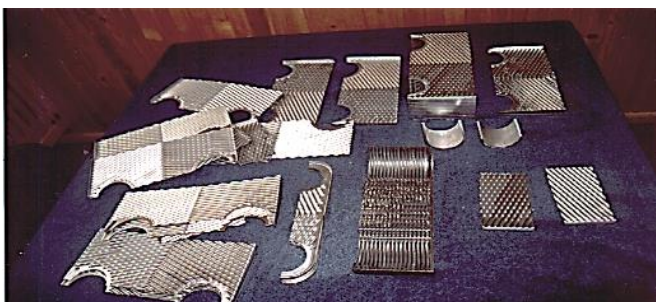
After numerous cleaning of HE with acidic bath, leakages mostly along external edges and between separated heating and heated medium, appeared. It was assumed that they could be a result of dissolution of thin corrosion product film with little metal. Particularities are hard to prove, when HE are non-demountable as plates are brazed with copper. The author, 15 years ago, disassembled the plates by immersion in 30% nitric acid, which effectively dissolved copper but not the plates from stainless steel. Such disassembling of the 100 kW HE lasts over one month. Disassembling of copper brazed HE may be significantly faster by cutting it into several elements and exposing to 30% nitric acid. Such procedure reduces time of HE disassembly to only a few days. Received plates may be examined visually and using microscope in order to assess possible corrosion. Plate HE elements after chemical disassembly are presented in Fig. 10.

Fig. 10 Copper-brazed plate HE, cut and disassembled chemically in nitric acid
